**A survey of the Pipe Organ at
St. George's Episcopal Church
Arlington, VA**

**John Santoianni
Advent Pipe Organ Services, LLC, Durham, NC
adventpipeorgan@gmail.com
November 24, 2013**

A survey of the pipe organ at St. George's Episcopal Church, Arlington, VA

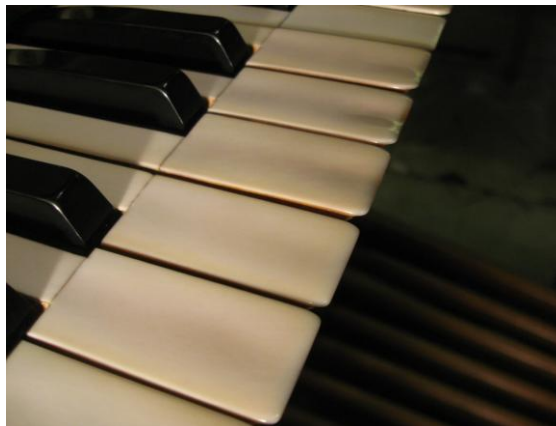
Because of use and age, the various components show sign of great wear. The keyboards and pedalboard generally receive the most wear, as is evident in the following photos. The ivory touch plates (key coverings) are scalloped in the middle of the keyboard (Figure 8). There is also too much side-to-side play in many of the keys because the felt bushings inside the key levers are worn out. This results in a noisy keyboard. More troubling for the player is the uneven adjustment of the contacts. When depressed, different keys strike their contacts at a different points in their motion, creating variations in when the pipes speak. This needs to be adjusted so the organist can rely on a consistent touch.

Figure 8: Scalloped ivories of the Great manual

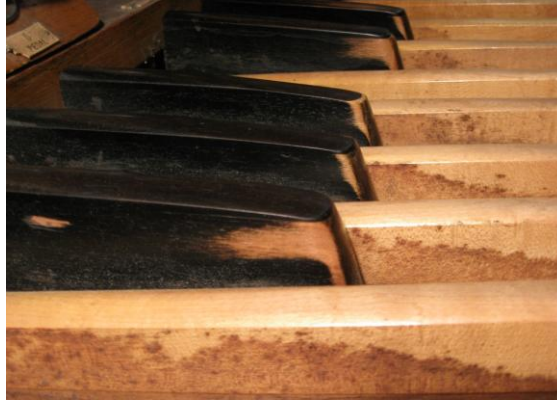
The pedalboard usually gets the most wear and tear of all components of a console simply because of the nature of how it is played. On this pedalboard, the ebony caps of the sharps are worn down, and the finish on the lower maple portion has been worn away by the feet. The pedal naturals show signs of mold and mildew, as well as wear on the upper surfaces (Figure 9).

Figure 9: The pedal keys showing wear as well as stains from mold and mildew.

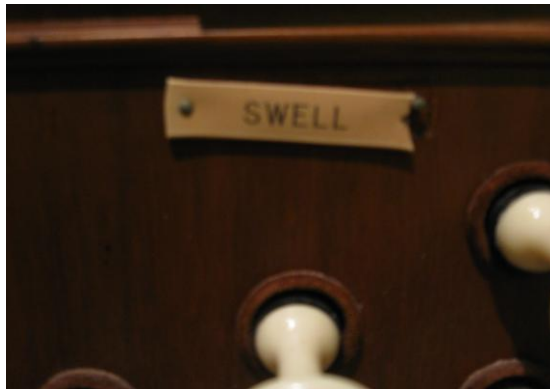
Nameplates are used on the console to identify assorted mechanical devices, including the stops for each division of the organ. All of the nameplates have become distorted with age (Figure10).

Figure 10: nameplate for the Swell stops.

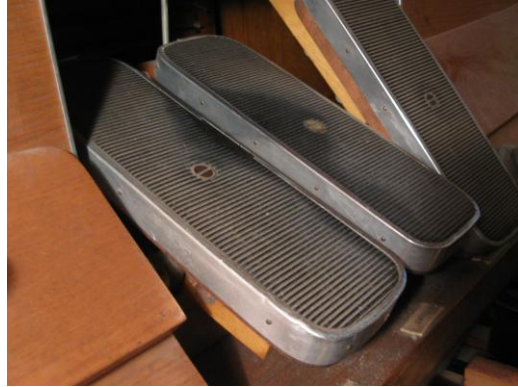
There are three pedals just above the pedalboard. Two of these control the **expression shades** (also called **swell shades**) for the Great and Swell. The third, on the far right, is the **crescendo pedal**. This pedal gradually adds stops as it is pushed forward. The expression pedals have seen a fair amount of use, and the rubber treads have worn down to a smooth surface in the centers (Figure 11).

Figure 11: The pedals for the Great and Swell expression shades; the crescendo pedal.

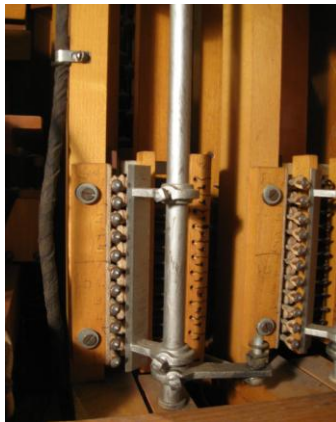
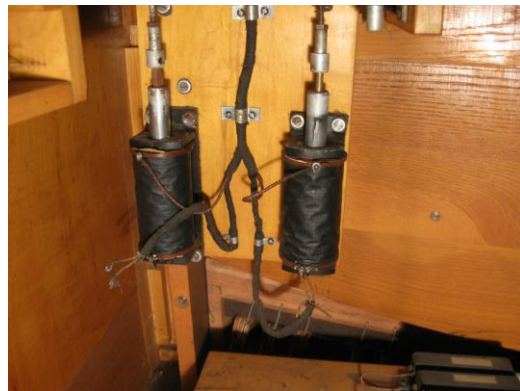
The Möller company was slow to incorporate the use of electronic components and stuck to its tried and true conservative versions. This console uses many solenoids to move stops and couplers. The motion of these solenoids can be sluggish and can add up to a lot of noise (Figures 12 and 13).

Figures 12 and 13: Parts of the Combination Action, and two large solenoids which operate part of it.

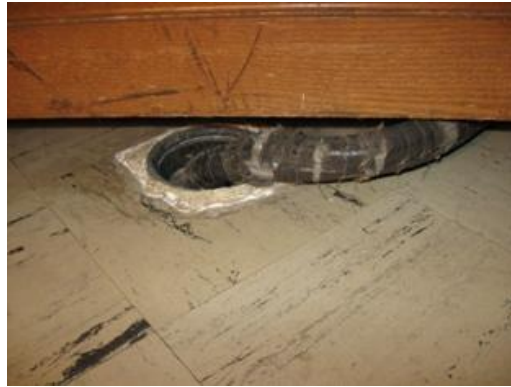
The console was fitted with 25 extra feet of cable, often called the umbilical cord, that exits the console at the rear (Figure 14). This cable can be pulled through a hole in the floor so the console can be moved to either side, or rolled in front of the screen for recitals or other events where the organist needs to be seen. However, the cable is fragile, so the console is best left in place: moving it could break wires in the cable, resulting in dead notes or dead stops.

*Figure 14: The cable, or umbilical cord, connecting the console with the relay.
Note its tenuous condition.*

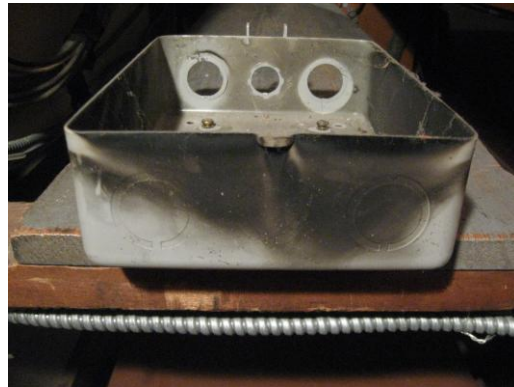
Figure 17: The cover from a former contactor that burned up at some point

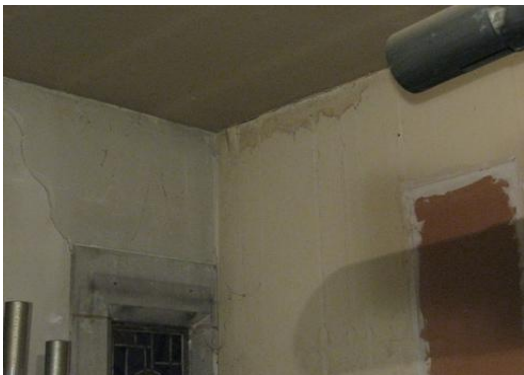
First, the chamber has three outside walls, presumably with a minimum of insulation if any. Since the stability of the tuning depends on keeping the chamber at the same temperature as when it was tuned, the heat or cooling loss through these walls is problematic (See Tuning Stability in the Glossary, page 49). Second, there is evidence of water damage in both chambers at the ceiling level and corners (Figures 18 and 19). It is clear that the rose window limited the height of the chamber, and the flat rather than sloping roof maximized the area of the chamber (Figure 20), but having a flat roof over an organ is simply asking for trouble. I am actually amazed that there isn't greater evidence of water penetrating the room.

Figure 18: Swell division, right rear.

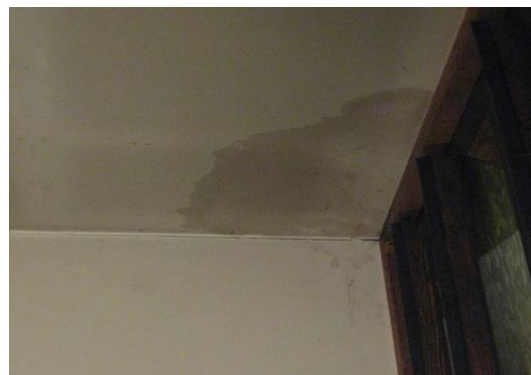
Figure 19: Great division, right front.

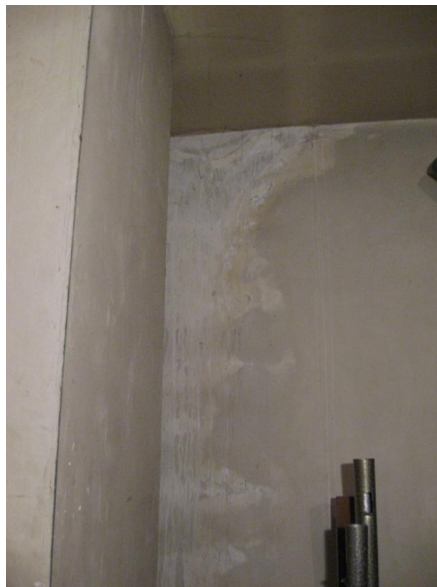
The worst water damage is found in the Swell division, left front, where plaster is flaking off (Figure 21). Fortunately, nothing has fallen into the pipework, especially the reed ranks, since even small pieces of debris can keep a reed pipe from speaking.

Figure 21: Swell division, left front, showing flaking plaster

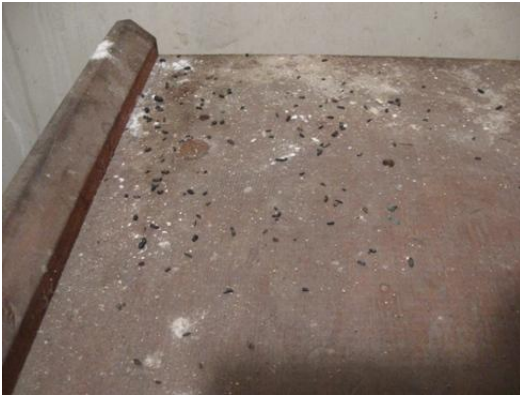
Figure 22: mouse feces, Swell front walkboard.

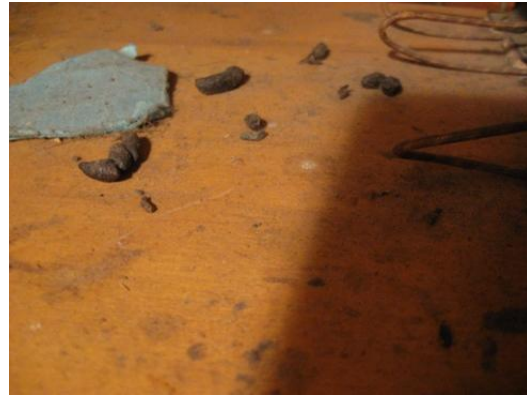
While I am not an authority on animal droppings, my presumption is that there has also been at least one squirrel inside the console, as evidenced by the larger and lighter colored feces (Figure 23).

Figure 23: Possible squirrel feces inside console.

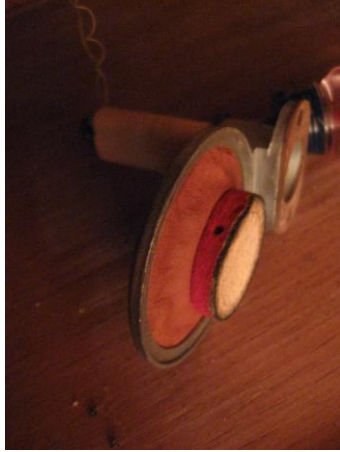
While not as terrible as rodent infestation, moths do damage certain parts of pipe organs. There is evidence of moth larvae in the felt disk of the Pedal/Great Principal 8 offset chest (Figure 24). The damage is minimal and has not affected the performance of the valves. Most felt used today is treated to be moth proof.

Figure 24: Evidence of moths in the windchests.

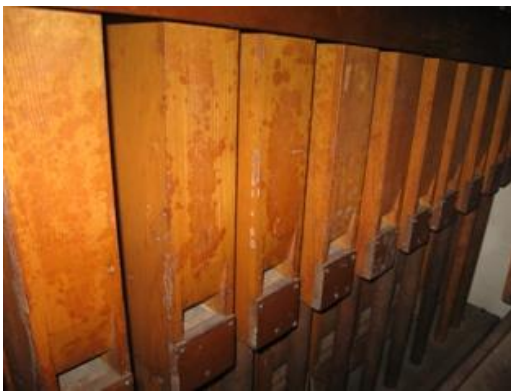
Mold and mildew are growing on the Pedal Bourdon 16 and on a windline in the Great chamber (Figures 25 and 26). This is a too-common occurrence in churches where the humidity tends to be high and the air circulation in the chambers poor. This happens even in recently built instruments when the conditions are ripe.

The mold on the wooden pipes is both active and dead. The white patches are growing; the darker patches are mostly stains from past growth. Washing the pipework in a strong bleach solution will kill the mold and mildew, but the stains will remain. (Of course, washing will not cure the problem of elevated humidity and poor ventilation.)

Figure 25: Bourdon 16 showing mold and mildew.

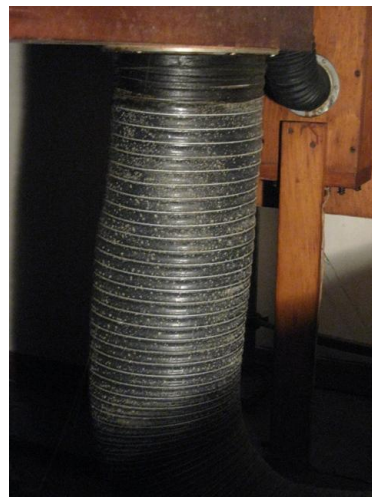
Figure 26: Great windline showing the same.

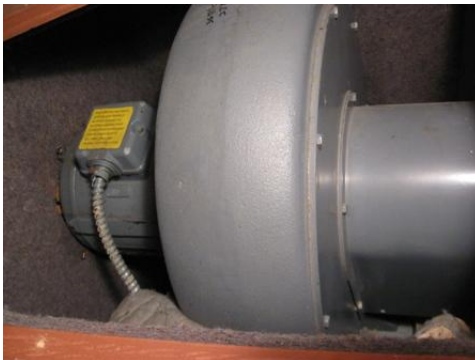
The very first thing I noticed when turning on the organ was the assault of wind noise. There is no better word to describe this, a point that cannot be overstated. This is one of the noisiest pipe organs I have ever encountered. Some effort was made to reduce the din, including putting the blower in a felt-lined muffler box and adding blankets to the box. A good deal of the noise is simply the turbulence of the wind coursing through the windlines. This is a failure of the design and execution of the relocation of the blower. There are also numerous leaks in the winding system that have developed over the years and that add to the roar. The shades would clearly need to be closed during services, when the organ is not in use, simply to reduce the noise.

The blower (Figure 29) was made by the Meidinger Company of Switzerland. This company discontinued the production of its pipe organ blowers some time ago, but many are still found in pipe organs. The 220 volt motor has sleeve bearings and runs at 3360 rpm. Typical of this brand, the housing is made of cast iron. Since the blower is installed in a muffler box with limited room for inspection, it was not possible to see the serial number plate. Based on its size, it is likely a half-horse power motor. As long as the motor is regularly oiled, it should run without problem for many more years. However, the bronze sleeve bearings are non-standard for American electric motors; should they fail, it will be extremely difficult, if not impossible, to replace them.

Figure 29: Meidinger blower in a muffler box lined with felt which is only partially effective in reducing wind noise.

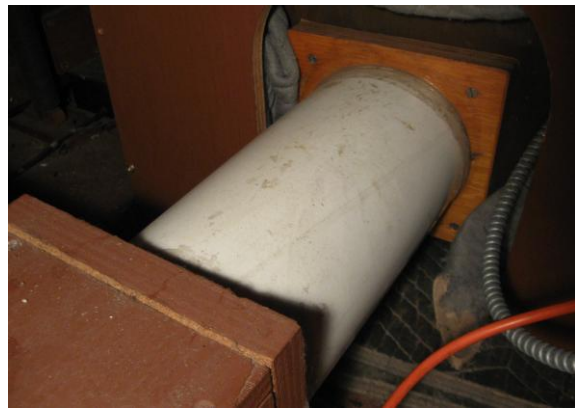
Windlines move the pressurized air from the blower to various wind-regulating devices (Figures 30 and 31). The original windlines were made of galvanized steel, with some connectors made of rubberized cloth. When the blower was moved from its previous location, large PVC pipe was used to connect the blower to the plenum (a junction from which other windlines emerge). While PVC pipe may not be the most attractive alternative to traditional metal windlines, it does provide a smooth inner surface, and it is inexpensive and readily available.

Figure 31: PVC pipe used to connect the blower to the plenum.

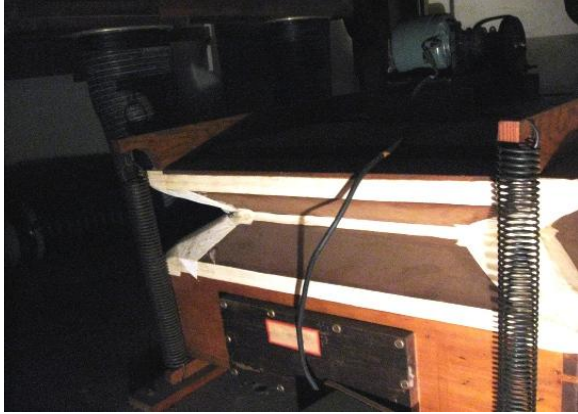
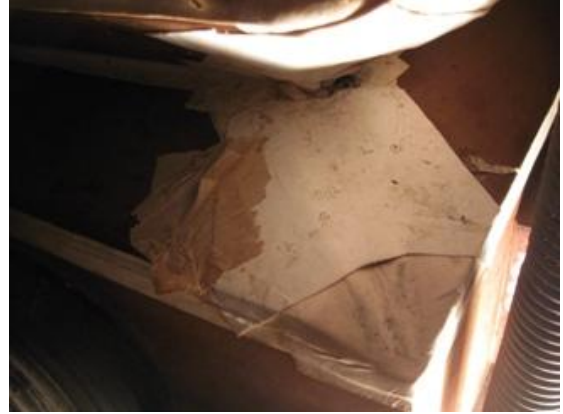
The Great division wind regulator, filled with pressurized air, is shown in Figures 32 and 33. A close-up of one of the leather corner gussets reveals several patches. On-site repair work can often be less than pretty, but the repair did stop the loss of wind. The overall condition of the leather on the regulators is nearing the end of its useful life, and more patches will be necessary if the regulators are not rebuilt.

Figure 32: Regulator filled with pressurized air.

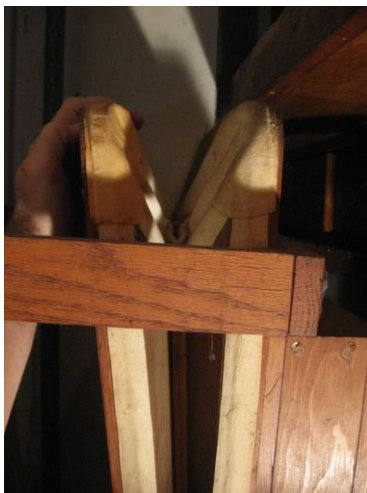
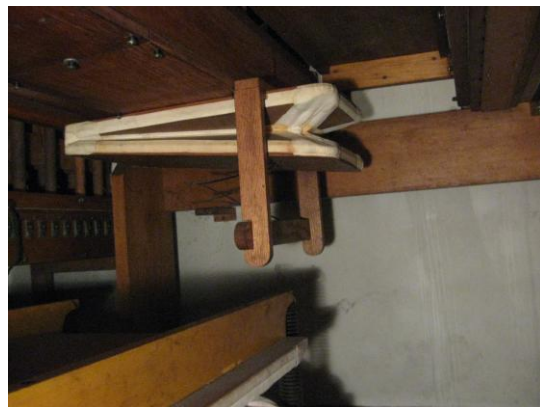
When many pipes suddenly speak all at once, the wind pressure in the windchests can drop. This can result in a sag in the pitch of the pipes. The problem is remedied by adding spring loaded concussion bellows: should the pressure drop, the bellows collapse, increasing the pressure until the wind regulator has time to recover. The Newcomer organ has three concussion bellows: one for the main Swell chest, one for the Great chest, and one for a large offset chest (Figures 34 and 35). These bellows need to move quickly and freely to respond to a drop in pressure. In their current state, with their leather old and hardened, their motion is restricted, making them less effective than they need to be.

Figure 34 and 35: Concussion bellows for the Swell and Great windchests.

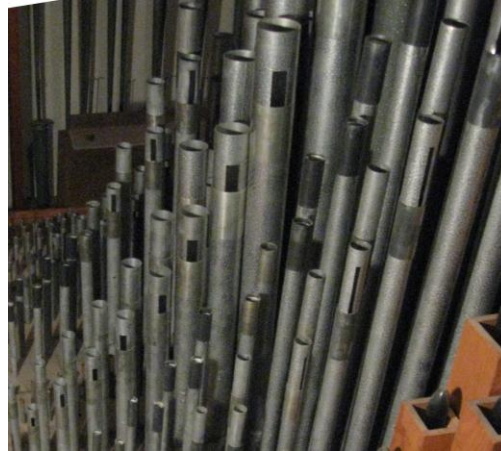
The metal pipes are tuned by moving a tuning slide up or down to make the pitch flatter or sharper respectively. As the slides are made mostly made of coke tin, they are resistant to corrosion, but not immune (Figure 38). For some reason, brass plated slides were used for the top octaves. Slides of this age can be difficult to move when tuning.

Figure 38: Metal pipes with coke tin tuning slides. Wooden pipes with stoppers lower right.

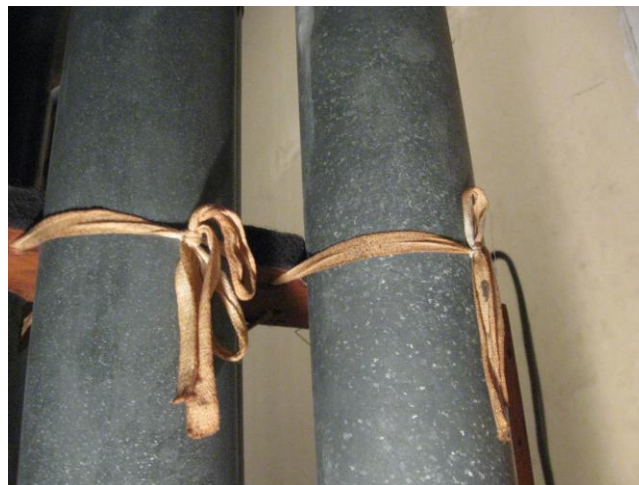
Pipes are held in place in a variety of ways. Larger metal pipes are often held in place with cotton twill tape (Figure 39). This tape is now almost 60 years old and is in fragile condition. This can be dangerous: falling pipework can injure the technician and will certainly damage the pipes.

Figure 39: Large zinc pipes held in place with cotton twill tape.

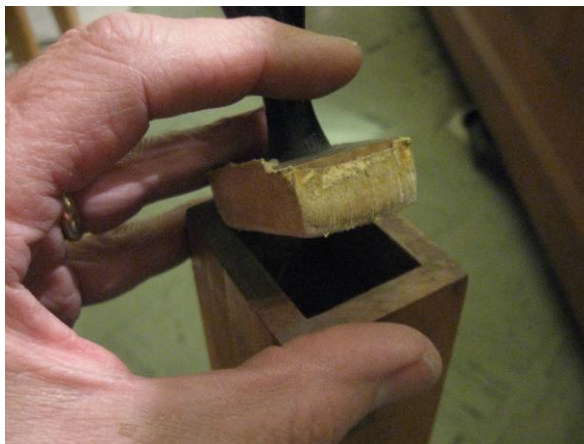
Most of the wooden pipes are stopped and half-length, meaning that a 4' pipe will produce a pitch twice as low as the length would suppose. The stoppers need to be packed with leather to obtain an air tight seal or the pipe will not speak properly (Figure 40). The fit of the stopper cannot be too loose or it may fall into the pipe, nor can it be too tight as this will make tuning difficult and may even crack the pipe. As the leather ages, it dries out and begins to disintegrate.

Figure 40: Stopper of a Stopped Diapason pipe showing old, dried leather.

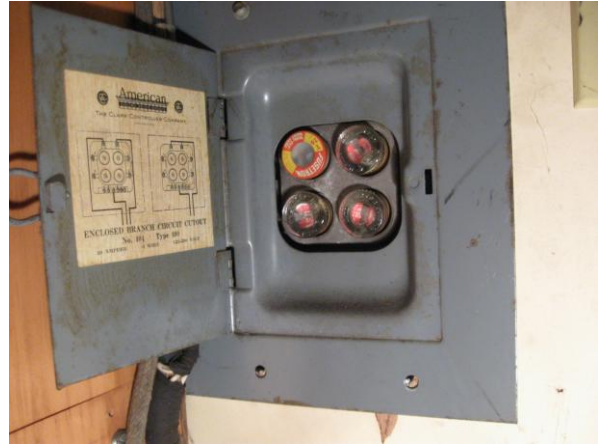
Inside the Swell chamber is a fuse box rather than a circuit breaker box (Figure 50). It is not clear if this still functions. If it is still live and a fuse does “blow,” there must be enough replacements on hand in the correct amperage. This should be brought up to current electrical codes.

Figure 50: Electrical box with screw-in fuses.

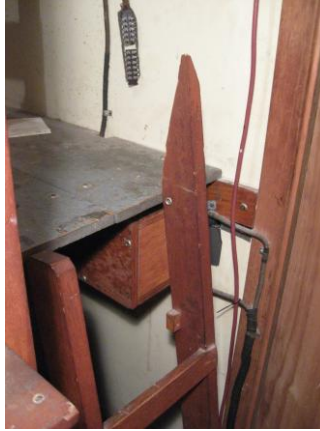
Figure 54: dangerous ladder in Great chamber.
