**A survey of the Pipe Organ at
St. George's Episcopal Church
Arlington, VA**

**John Santoianni
Advent Pipe Organ Services, LLC, Durham, NC
adventpipeorgan@gmail.com
November 24, 2013**

A survey of the pipe organ at St. George's Episcopal Church, Arlington, VA

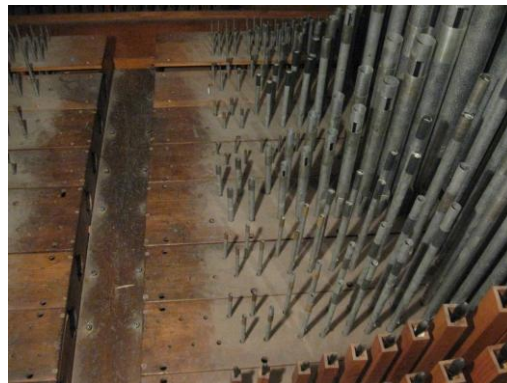
Figure 5: A section of the upper portion of the Swell windchest showing the rackboard and pipes, and quite a bit of dust.

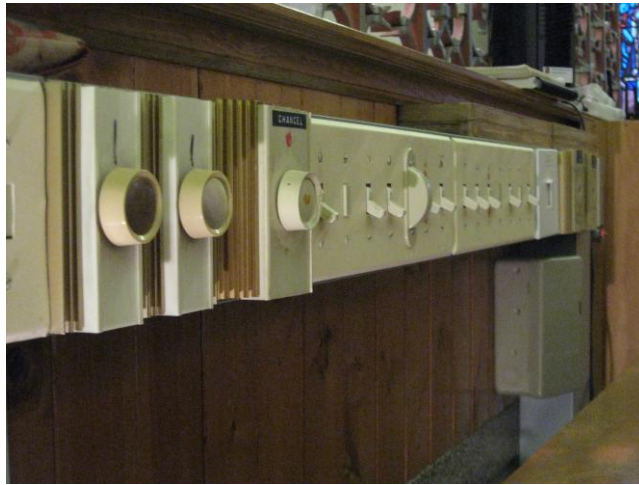
Behind the console are nineteen switches for the lighting. This is the greatest number I have ever seen next to a console. The organist has enough to do during a service without having to be the lighting designer as well. These numerous switches need to be at least moved or better yet converted into a more modern system. This needs to be addressed with the planned renovations.

Figure 15: An extremely large number of lighting switches and rheostats, clearly intended for the organist to control.

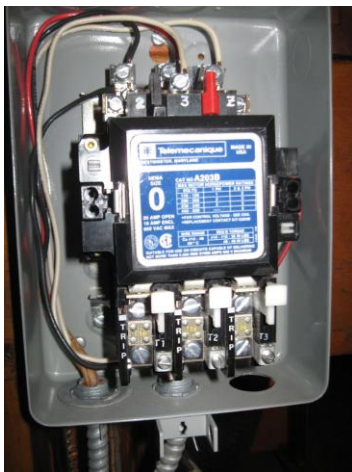
Figure 16: The contactor for the blower motor

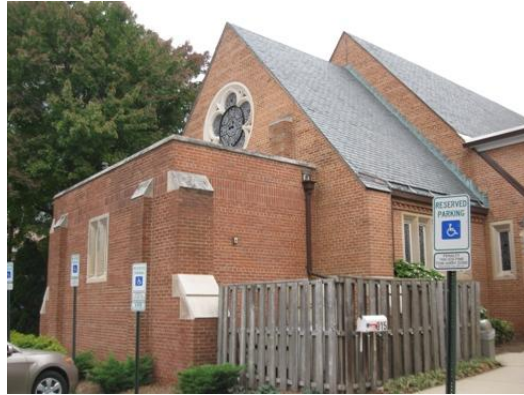
First, the chamber has three outside walls, presumably with a minimum of insulation if any. Since the stability of the tuning depends on keeping the chamber at the same temperature as when it was tuned, the heat or cooling loss through these walls is problematic (See Tuning Stability in the Glossary, page 49). Second, there is evidence of water damage in both chambers at the ceiling level and corners (Figures 18 and 19). It is clear that the rose window limited the height of the chamber, and the flat rather than sloping roof maximized the area of the chamber (Figure 20), but having a flat roof over an organ is simply asking for trouble. I am actually amazed that there isn't greater evidence of water penetrating the room.

Figure 20: The organ chamber viewed from the parking lot. It would be interesting to find out how many people know that this actually houses the pipe organ.

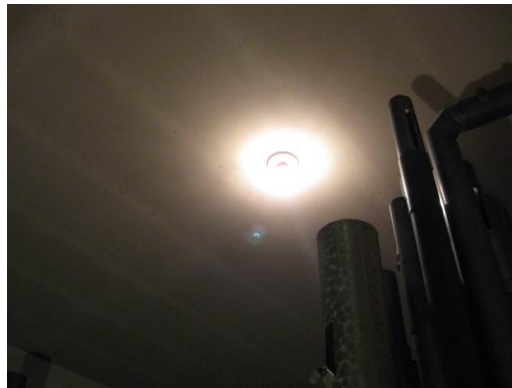
The only lighting in the chambers, other than what spills in through the open shades, is one incandescent light bulb for each side (Figure 27). This only dimly illuminates the top of the chests. For any work that needs to happen underneath the chests, the technician needs to bring in a drop light or use a headlamp.

If the chambers are not well lit, the technician is less likely to see problems which need attention. Poorly lit chambers make repairs more difficult, and colleagues have confirmed that they are less likely to make an onsite repair where lighting is poor.

Figure 27: Incandescent lighting in the Swell chamber.

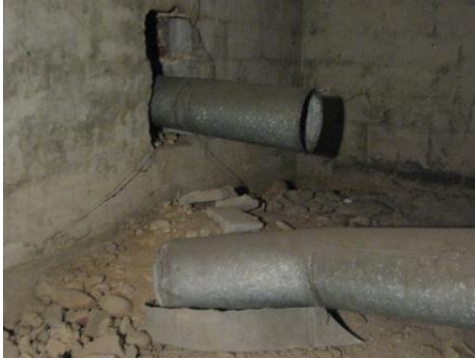
At some point the blower for the organ was moved from its former location in or near the Boiler Room to the Swell side of the organ chamber. (The galvanized former windlines remain visible to those willing to venture through the trap door; Figure 28.) This move ensured that the air entering the windchests was the same temperature and humidity as in the chambers. The downside was that it greatly increased the amount of wind noise coming from the chambers.

Figure 28: Former windlines under the chancel

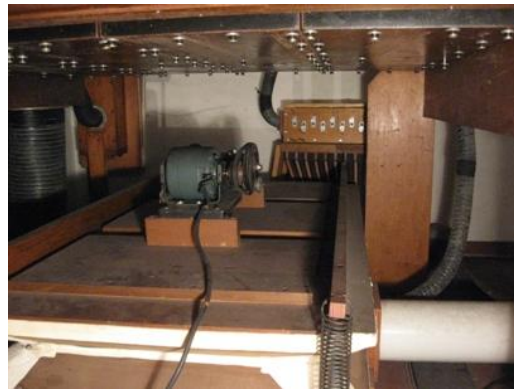
The unit for the Great works well enough, but the Swell unit makes noise when on. I was not able to trace the sound, but it did not appear to be the bearings on the motor.

Figure 36: The tremulant motor on the Great wind regulator.

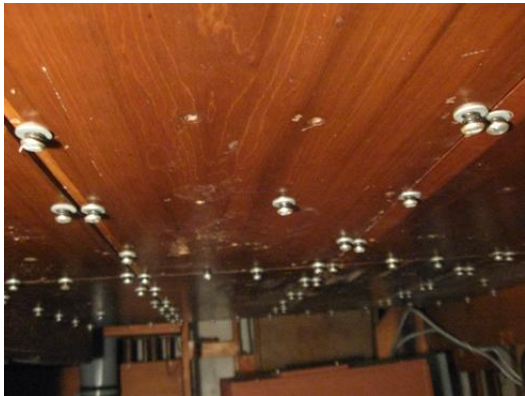
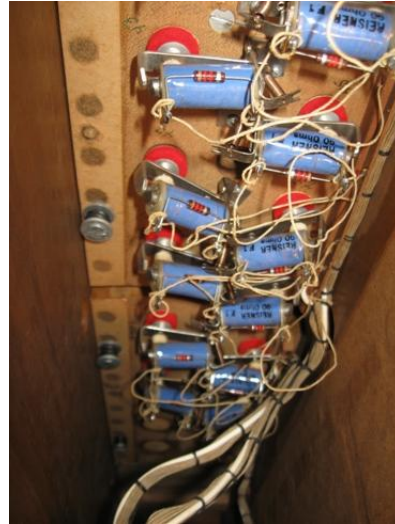
Sadly, only 15 years later, the organ was to receive a major overhaul, including the removal of the pouchrails from the main chests and replacing them with “electro-magnetic actions,” according to the contract prepared March 3, 1970. This type of action is more commonly known as a direct valve action, or direct electric (Figures 41 and 42). The magnets typically use between 12 and 15 volts DC supplied by a rectifier.

It is not clear from the contract why the change was made so soon after the installation. While the leather used in 1955 may have been “specially tanned for organ use,” the quality of the leather or the tanning process may not have as high as presumed. Extreme heat and cold may have lessened the life expectancy of the leather. In viewing the overall project, using direct valve action as a replacement was no doubt the least expensive alternative to releathering all the pouchrails, with the expectation that it would last longer than leather. Bear in mind that there is one pouch for each pipe in the organ, and either alternative meant around 1200 new direct valve actions, or pouches, or a combination of both.

Figure 41: Underneath the Swell chest showing the bottom boards.

Figure 42: With a bottom board removed, a view of the Swell chest, showing the direct valve action.

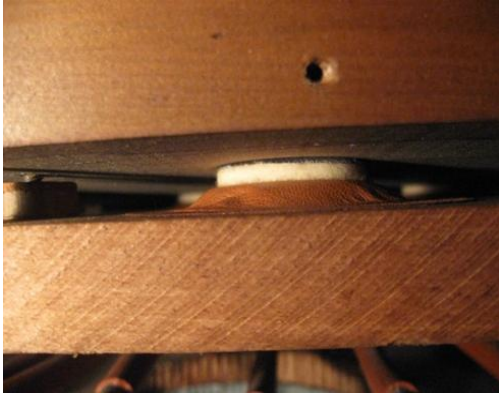
The electric action shown above is often not able to accommodate the size of the opening in the windchest needed for the larger pipes. Consequently, in this organ, two different types of action were used. For some offset chests, the original pouchboards were releathered (Figure 44). For other offset chests, a direct valve action was used (Figure 45). It is unclear why the builder did not simply choose one or the other, rather than using two different actions. These two types of actions should both move at about the same speed, so there should be no discernible difference between the two.

Figure 44: Pedal offset chest with releathered pouch.

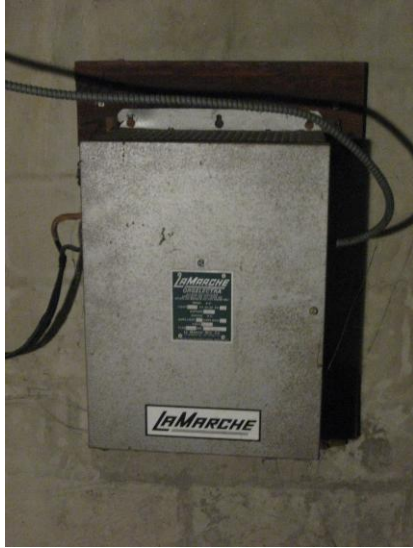
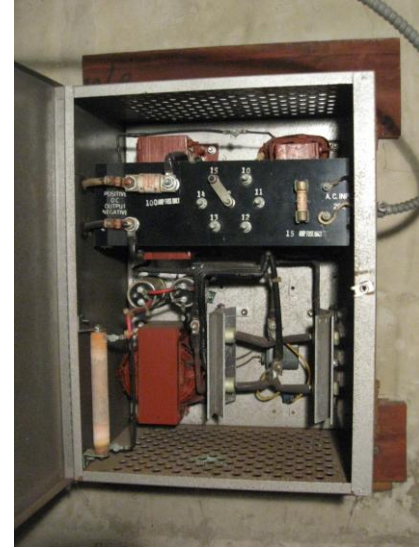
Most electric parts of pipe organs run on at least 12 volts direct current (DC), the same as a typical automobile. A rectifier transforms household current of 110 volts alternating current (AC) into DC. The rectifier for this organ is located beneath the choir and was newly installed during the 1971 work (Figures 47 and 48). While old, it appears to be functioning well, and does not show signs of deterioration.

Figure 47: The rectifier under the choir.

Figure 48: Inside the rectifier, showing it is set for 15 volts DC.

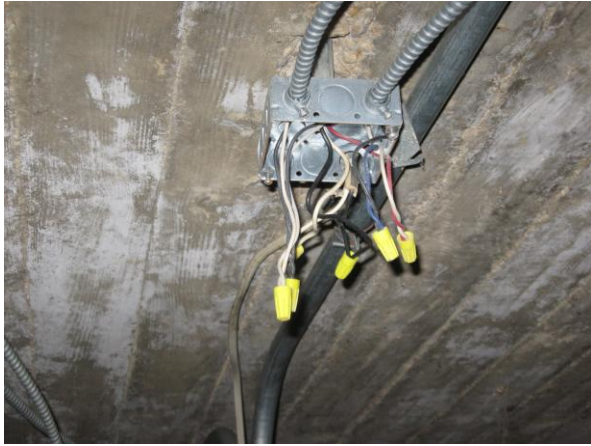
Underneath the choir, in the area where the rectifier resides, is an open electrical box that clearly should be covered (Figure 49).

Figure 49: open electrical box.

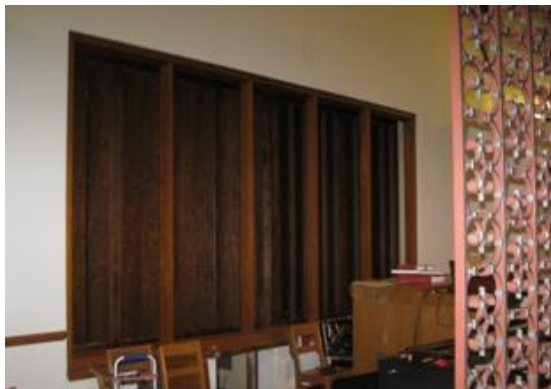
A letter from Newcomer dated August 17, 1971 discusses removing the grille cloth and sending samples (colors and styles of weave) for replacement. The issues were its condition as well as mold and mildew. No action seems to have been taken at that point. It is thought that the cloth was removed between 1977 and 1981, but nothing replaced it. The shades and frame were possibly stained a darker color at this point, but this is just speculation.

Figure 51: Expression shades.

It seems unusual that no action was taken to replace the cloth, since the typical aesthetic for such an installation would have been to cover what would have been considered unsightly shades. However, not covering the opening would improve air flow, which would help the stability of the tuning. It was probably too late to help with the mold and mildew issue.

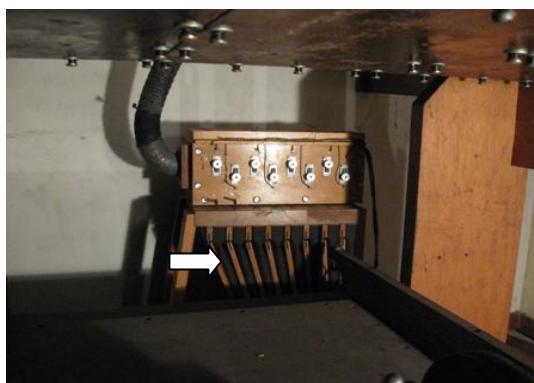
The device that moves the shades is called an expression or swell machine. The type used here has rubberized cloth envelopes; these inflate or deflate to move a control arm, which in turn moves the shades. The arrow in Figure 52 points to these envelopes. The shades are connected with a control arm so they move in unison.

Figure 52: Eight stage swell machine.

There are eight stages to these swell machines, although there is a problem either with how they are adjusted or with the contacts at the expression pedals at the console. There should be eight distinct incremental stages of motion visible with the shades, but the Swell side only reveals five, and the Great side seven. As these machines were recently rebuilt according to information in church records, I presume that this is an issue of adjustment. Being out of adjustment means that there cannot be a smooth crescendo or decrescendo, since some stages of motion are simply too great. This should be investigated and corrected for the benefit of musical performance.

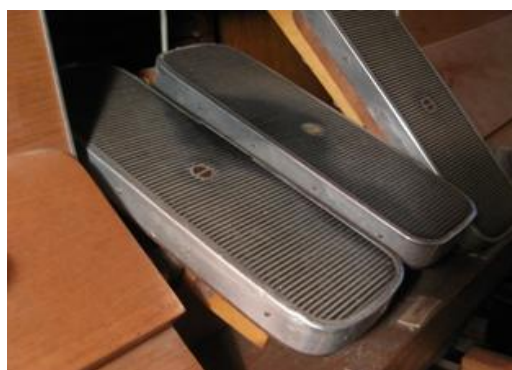
*Figure 53: Expression pedals for the Great and Swell in their open positions.
On the far right is the crescendo pedal.*
